Deck Repair Grady White Runabout

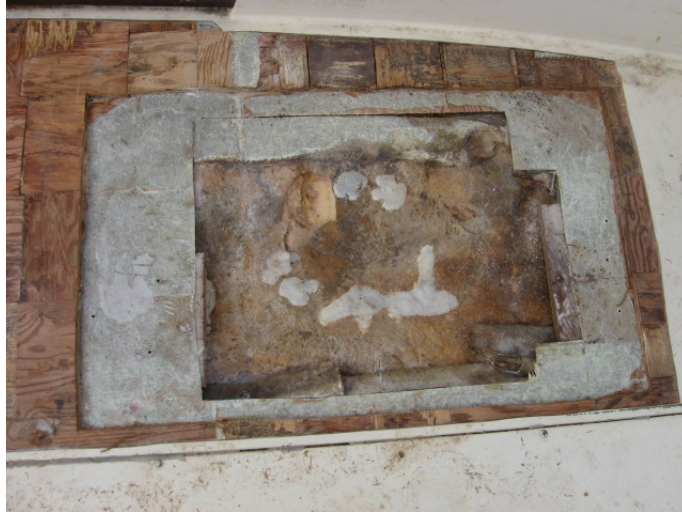
Once the cut outs were removed, some longitudinal stringers were noted on the edges of the cut. These will support the downward weight of the plate once installed.

Figure 1 Cut out showing ledge and underdeck

The next step was to cut out the core leaving a ledge around the perimeter upon which the deck would be reinstalled. It is critical to try to maintain the ledge so the reinstalled deck will match the elevation of the existing decking. It was also deemed beneficial to leave a ledge of the underdecking upon which the new core plate would rest. Again, the MultiMax was used to cut the core. Care was taken to cut only the core and not the underdecking. Once the cut was made, the core was removed with a painter's tool leaving the underdeck.

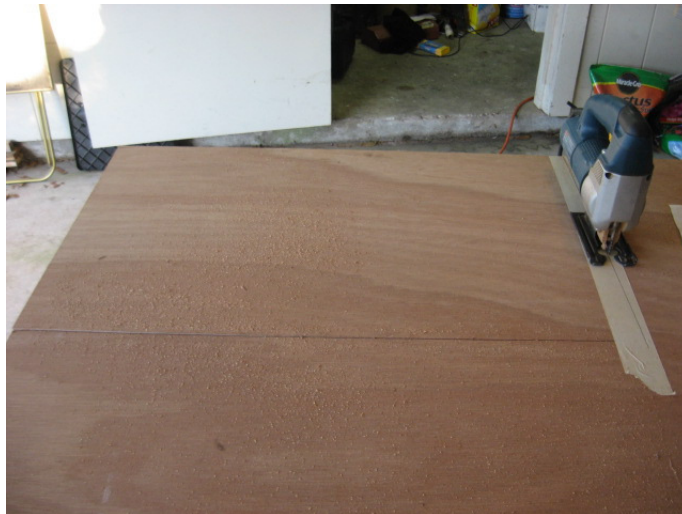
Figure 2 Use masking tape on crosscuts to minimize splintering

The exposed core was sanded to remove any adhesive and splintered core. The underdeck was sanded to remove all traces of core. The replacement core plate was cut to fit the core cut out. Although not entirely necessary for a piece that won't be seen, masking tape was applied for the crosscut to minimize splintering.

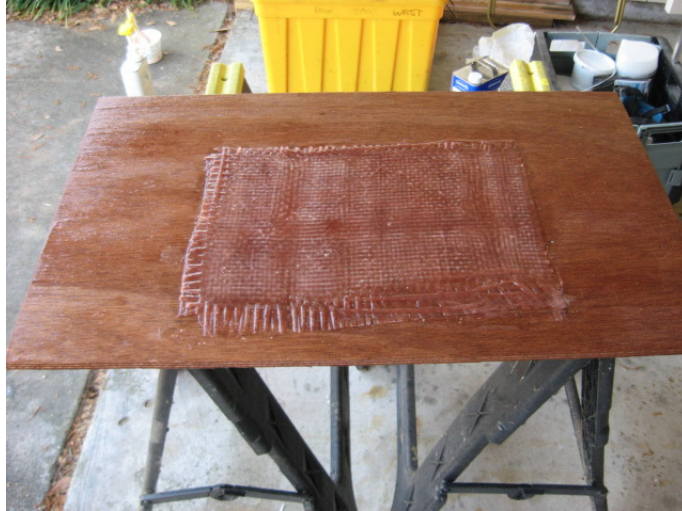
Figure 3 Roving was used to make a backing plate

The piece was marked to designate the up side and forward edge. Several layers of epoxy saturated roving were applied.

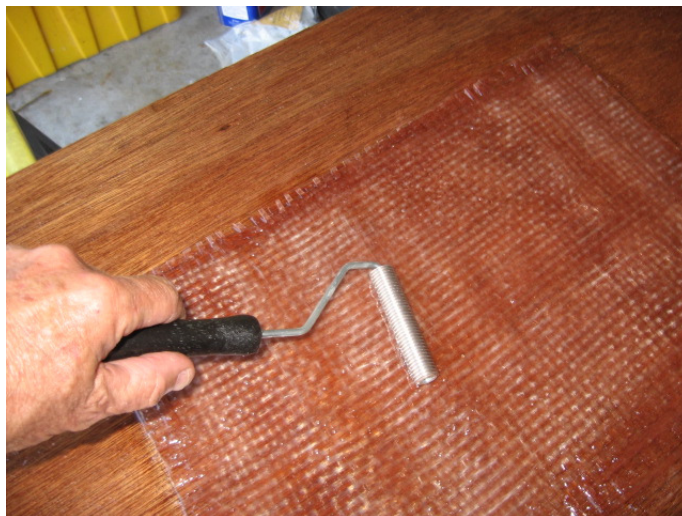
Figure 4 A laminating roller removes trapped bubbles

After wet out, a laminating roller was used to remove trapped air.

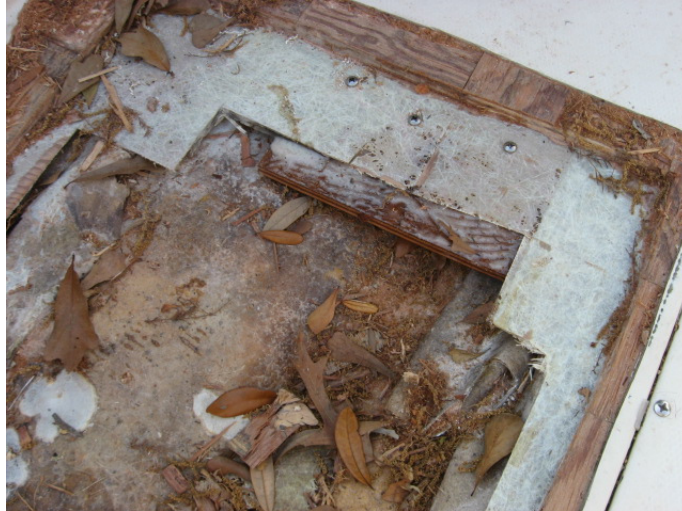
Figure 5 Close up of cleat under deck with screws to hold while epoxy cures

Thickened epoxy was applied to the cleats. The cleats were positioned under the existing uncut deck forward and aft of the cut out. Small screws were installed to pull the cleats against the underdeck until the epoxy cured. After curing, the screws were removed and the screwholes sealed with epoxy.

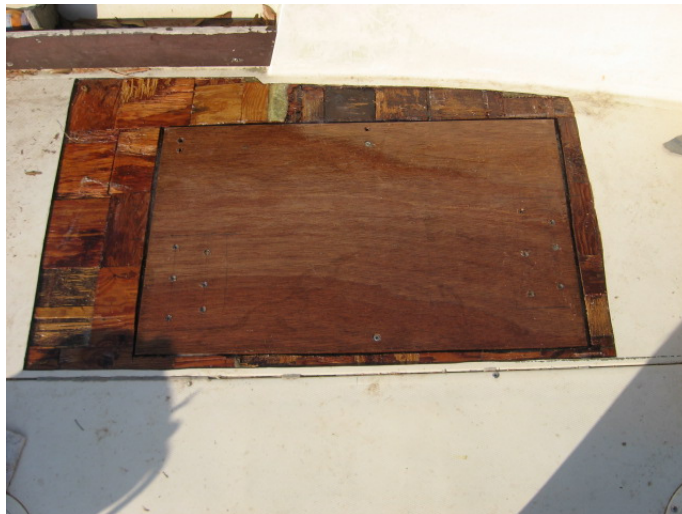
Figure 6 New core plate in position with countersunk screws and epoxy.

Thickened epoxy was applied to the underdeck ledge and the new core plate was installed using thickened epoxy. Screws were used to attach the plate to the cleats and to the longitudinal stringers. All screws were countersunk to provide a flat surface upon which to reinstall the deck. All exposed core was coated with epoxy.

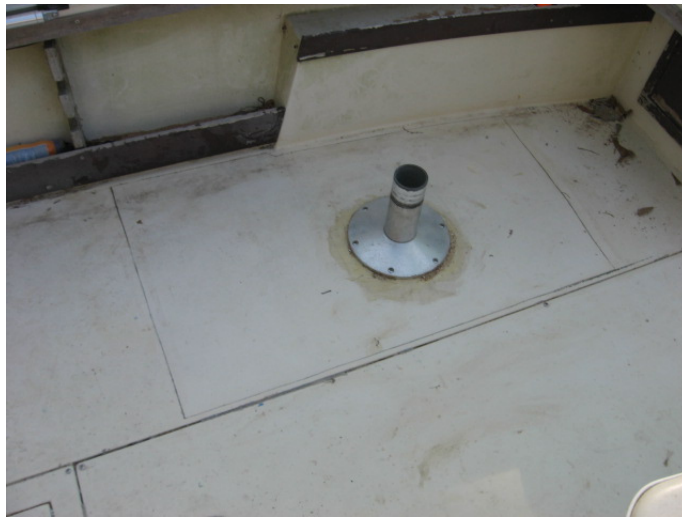
Figure 7 The finished repair with pedestal base installed

The pedestal base was reinstalled. It was positioned to hide the cut made by the deck collapse. There was a noticeable increase in torque required on the fasteners when they reached the fiberglass backing on the underside of the plate.
