Idler Plate on a 1990's C&C 34/36

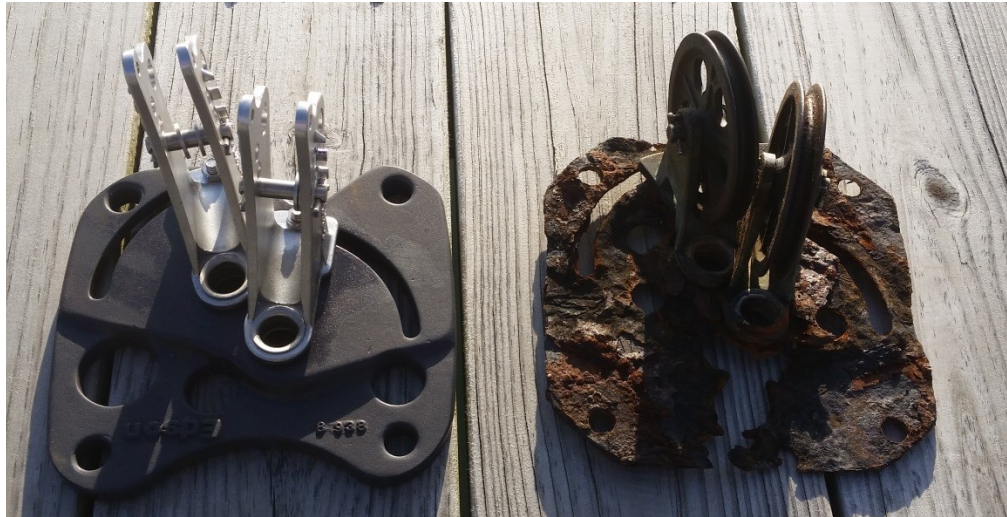
Here are some pics showing the new plate compared to the old one.

The original Edson plate was made from mild steel. It was cut and pressed into shape and painted black and is no longer made. The new Edson plate has a thick cast aluminum base with stainless sheave towers that are too long to fit our boats and have to be cut down to fit into the well under the pedestal. Using the lowest hole in the tower, I found I needed to lower the quadrant on the rudder shaft about 1/2". My old sheave towers are bronze and I wanted to reuse them but they are riveted onto the old plate. I contacted Edson several times but they never offered me good options. Bronze would make a better choice for something so important.

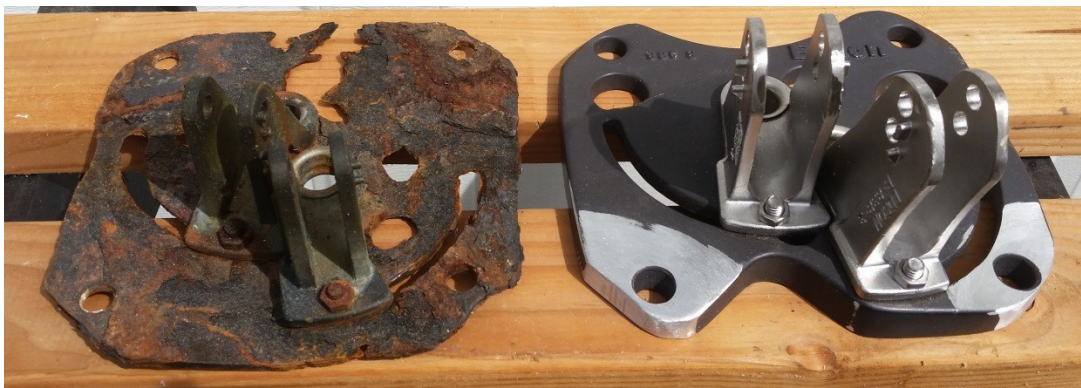
The new plate after modification

In the beginning, I thought I could grind the aluminum base or the fiberglass well, down enough to fit flush, but adding a trim ring between the pedestal and cockpit floor, made more sense. I was afraid to reduce the thickness and strength of fiberglass in the well. In the end I made a trim ring of 3/8" expanded PVC sheet. It can be found in 2015 at lumber yards for \$75 for a 4' x 8' sheet and they will cut it down so you can fit it inside a car. Great stuff to use on any outdoor project. It may be possible that 3/4" PVC or Starboard would reduce some grinding, not sure?

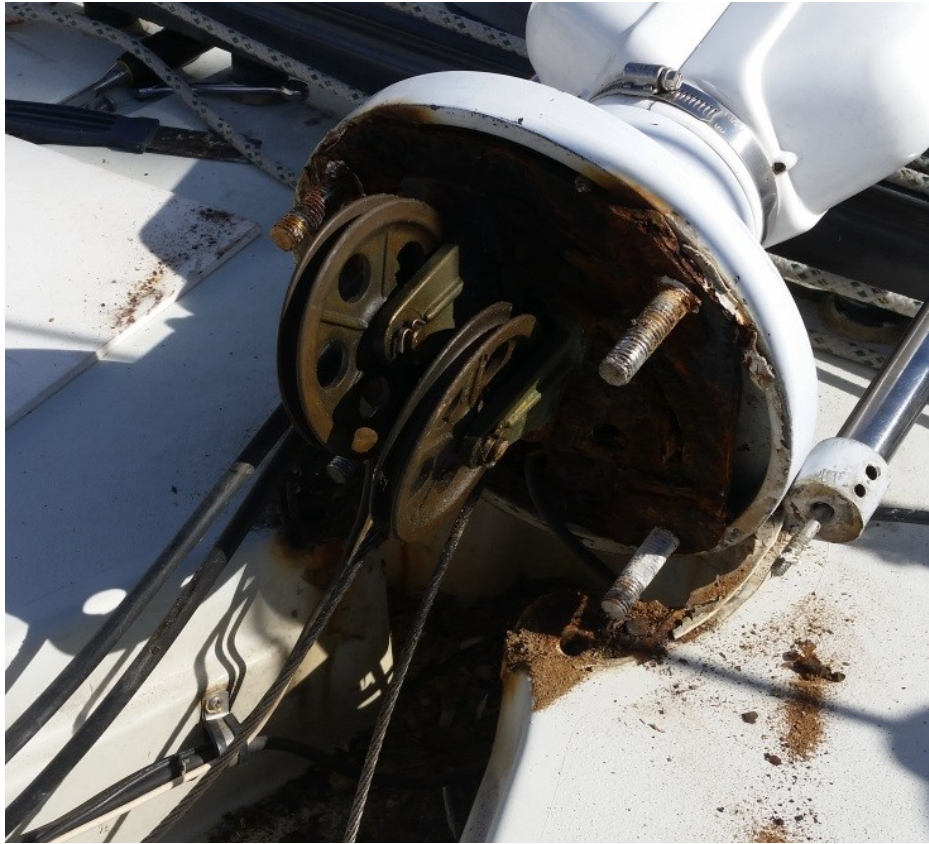
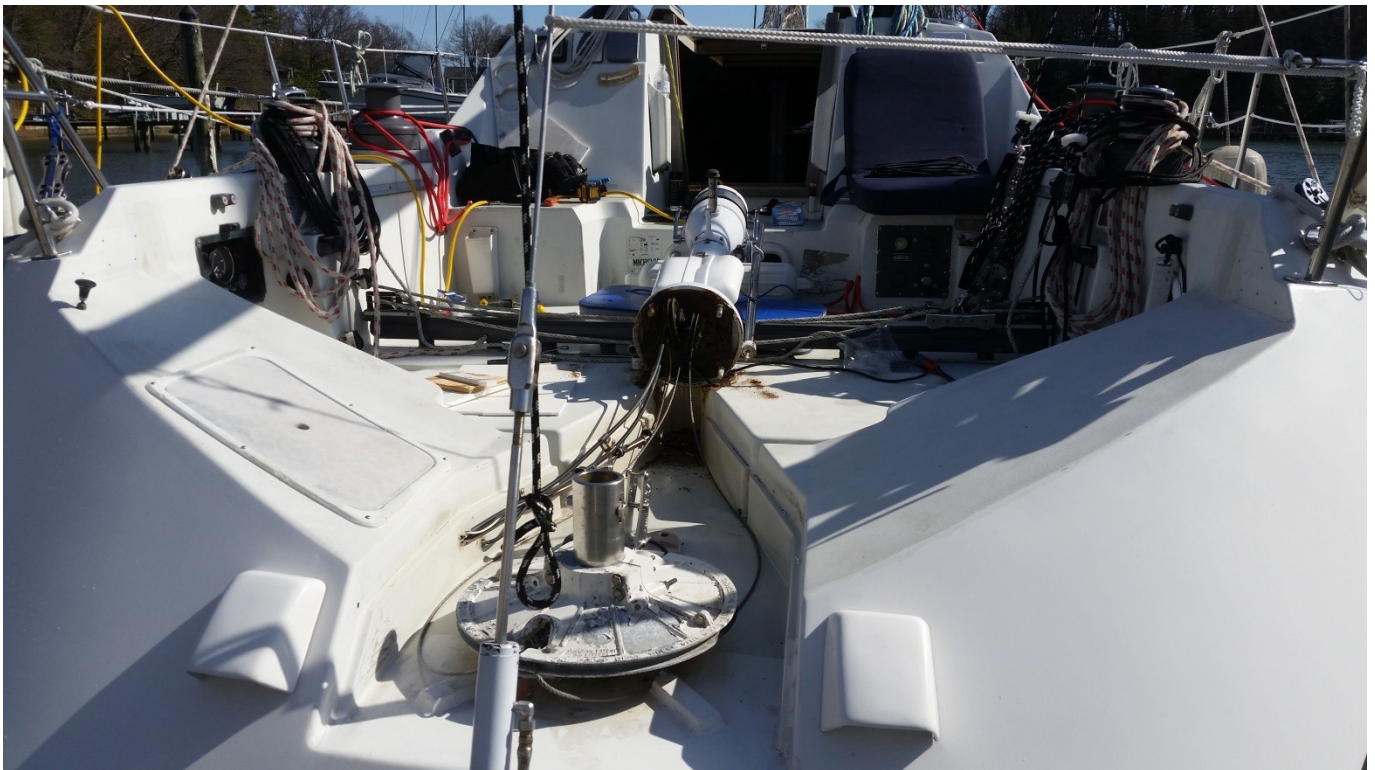
Brown Rust under an aluminum pedestal is a bad sign:

My steering system was trouble free for 12 years before I noticed about an inch of play in the wheel. Over the years, I had periodically oiled the cables and sheave axles but never needed to adjust the cables. Suddenly I had play in the wheel and slack in the cables. Upon lifting the cockpit floor section to access the quadrant and cable, I saw a small pile of rust under the pedestal base. I tapped the bronze sheaves and larger chunks of rust fell out like peanut brittle.

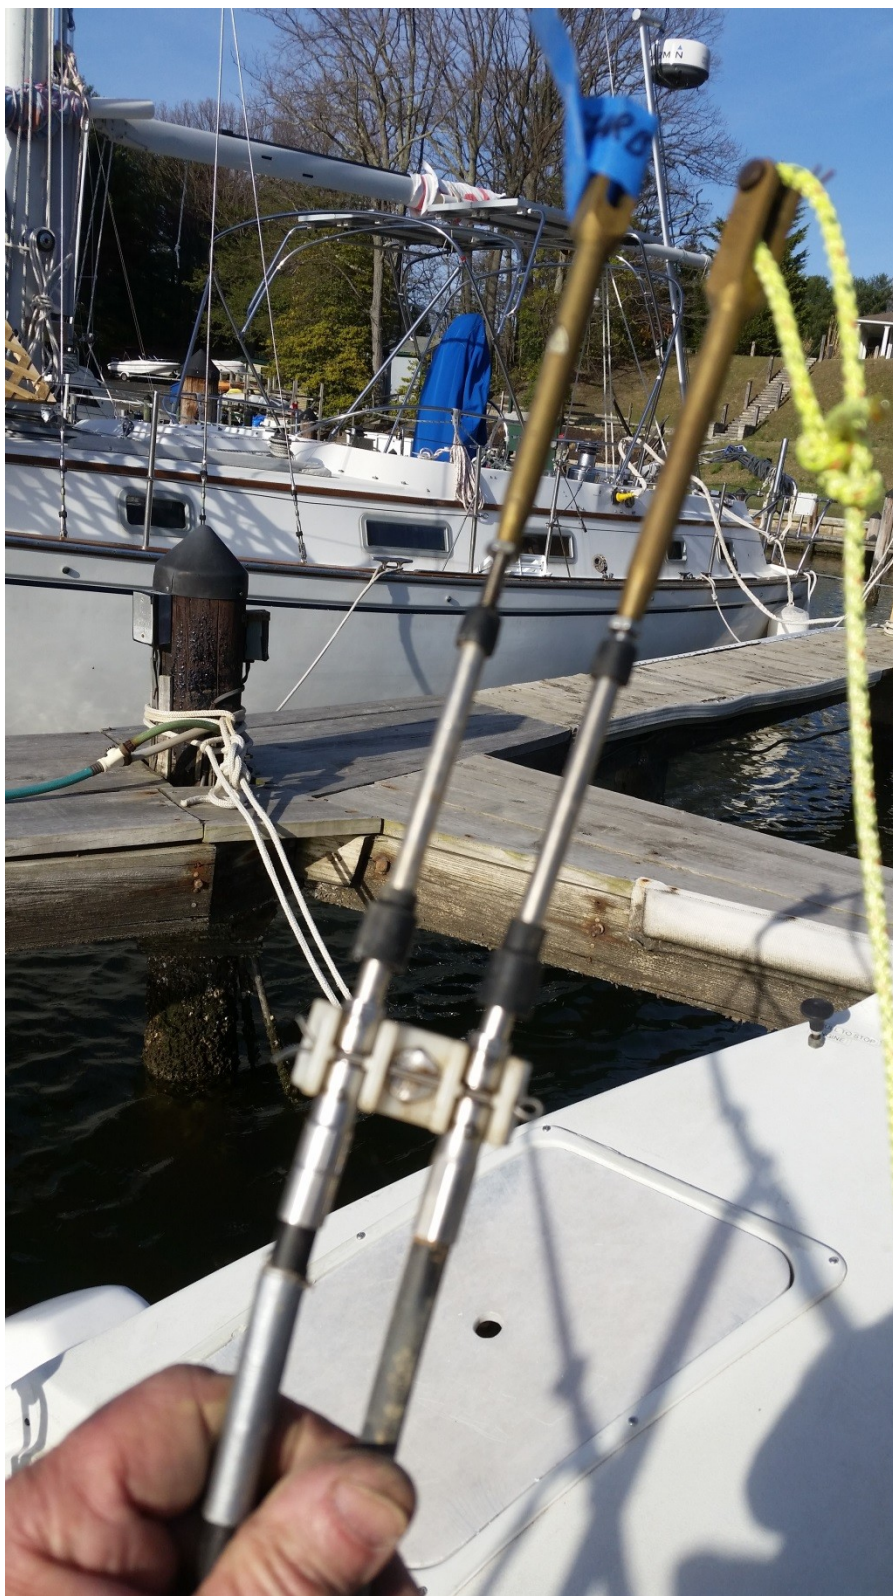
Throttle and shift cables marked.

If you attempt this project, be sure to mark the pedestal (blue tape) before disassembly and keep all parts, screws, nuts in order. For the base, I bought stainless bolts and aircraft nuts and large fender washers for a fraction of the cost of one aluminum bolt from Edson. SS is much stronger and doesn't seem to affect my compasses.

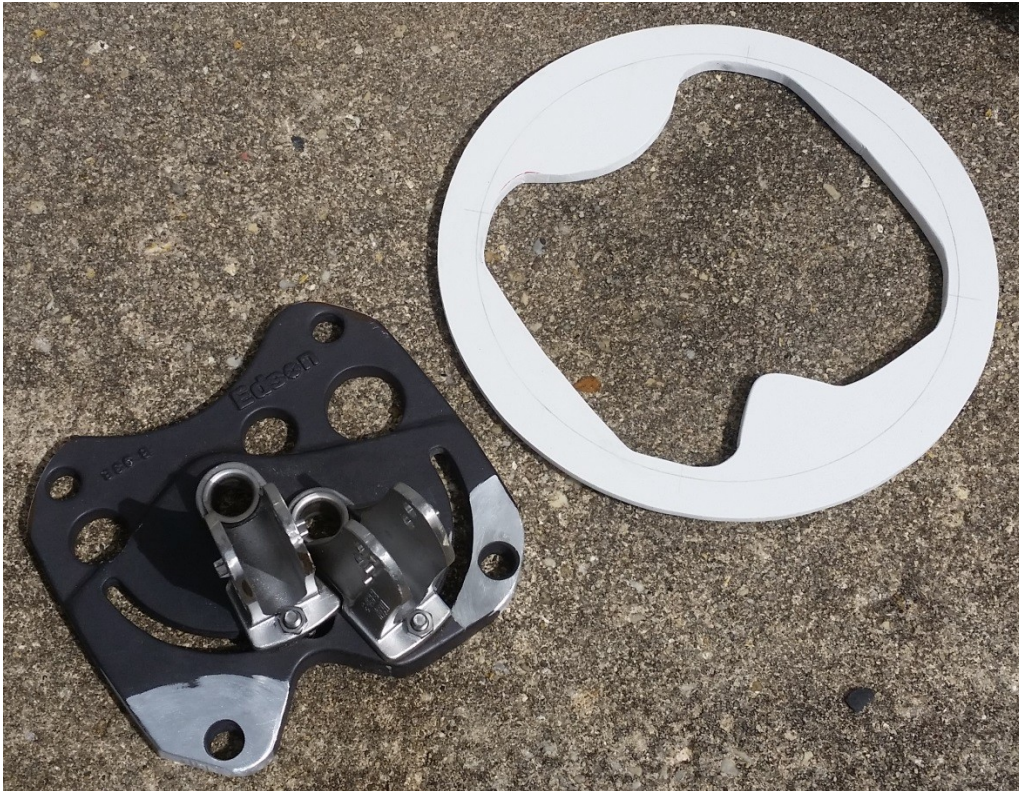
Pencil line on trim ring shows the pedestal outline.

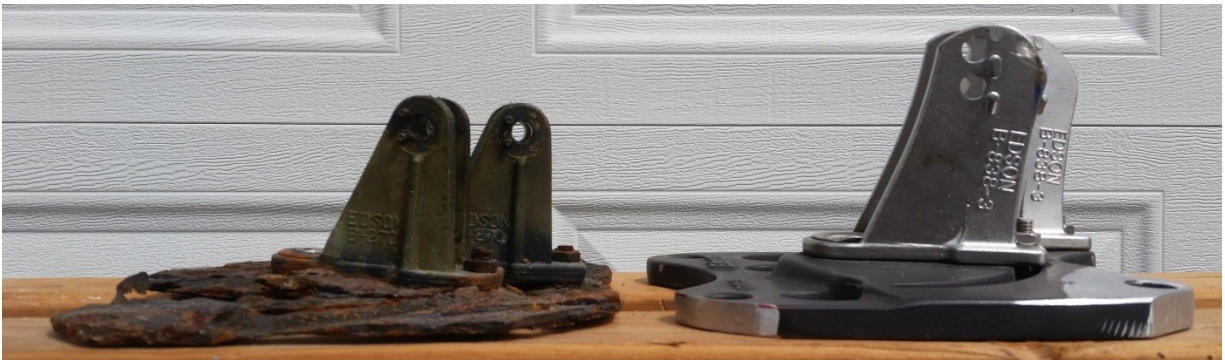
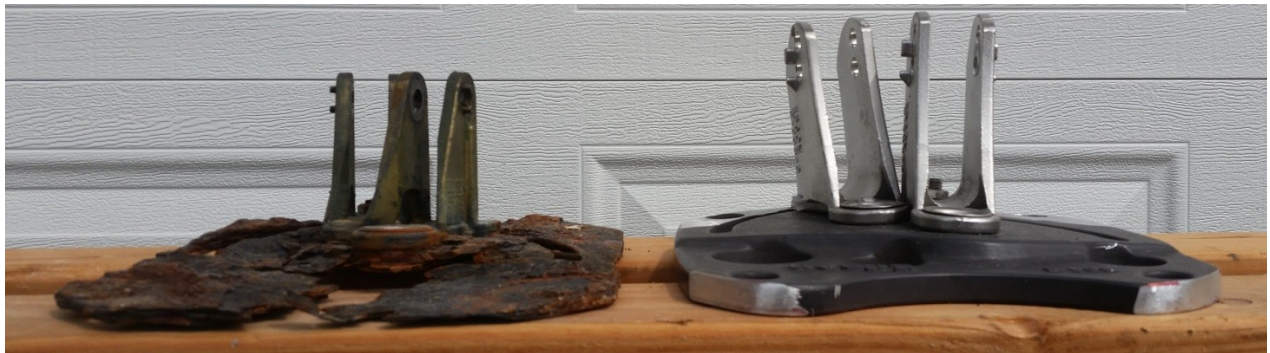
Compare holes for pulley axles: New position will be $\frac{3}{4}$ " lower in the deck well.

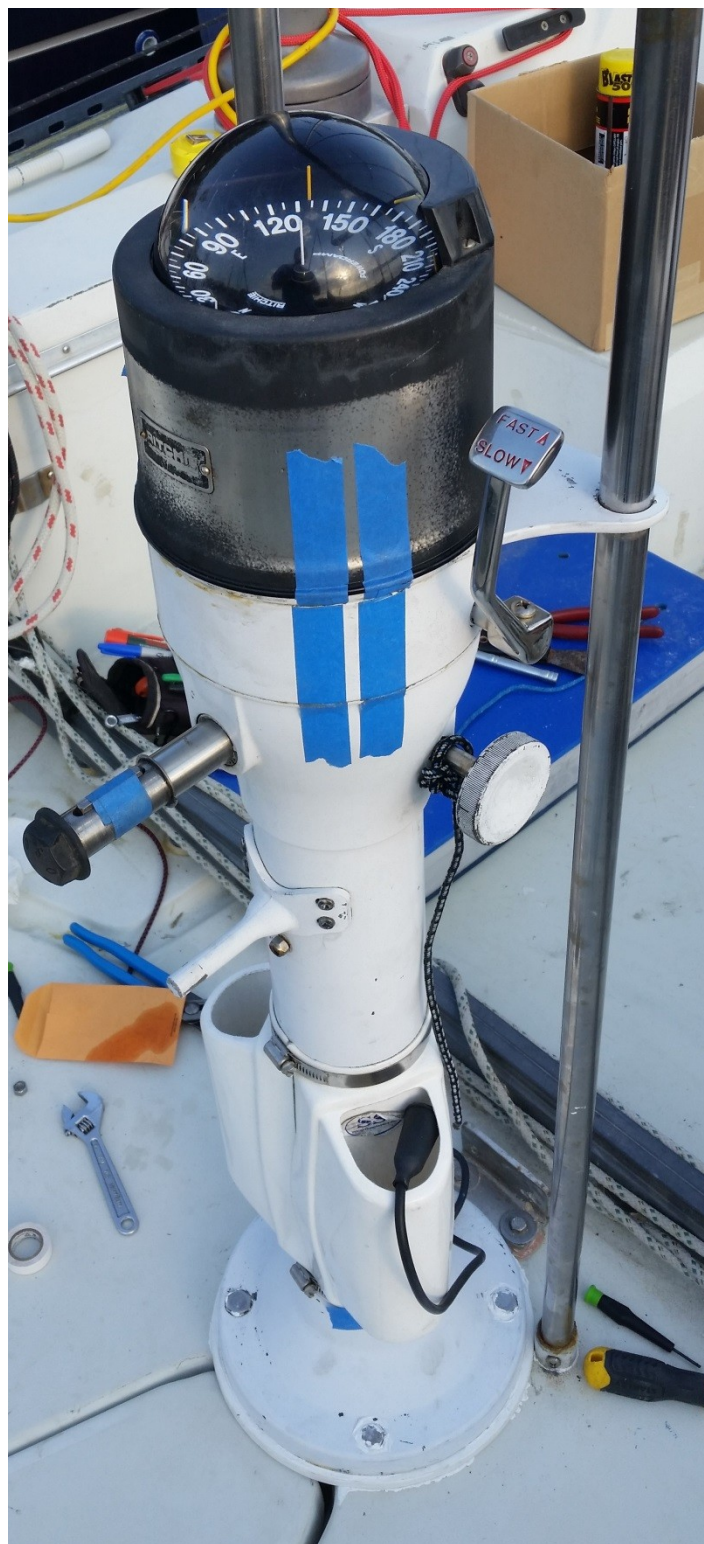
Starboard side, key taped on shaft

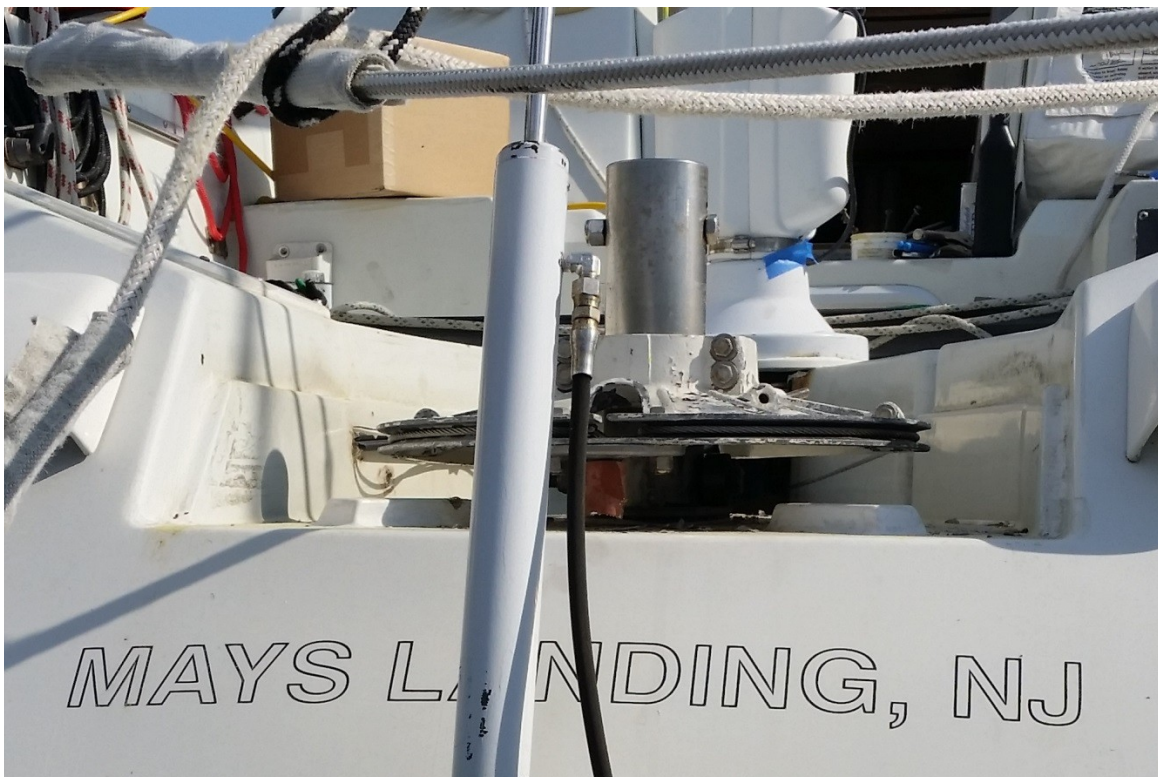
The quadrant needs to be lowered to get a fair alignment to idler pulleys.
